A MINIMALLY INVASIVE TREATMENT FOR
VERTEBRAL COMPRESSION FRACTURES

VERTEBRAL AUGMENTATION

Patient Information

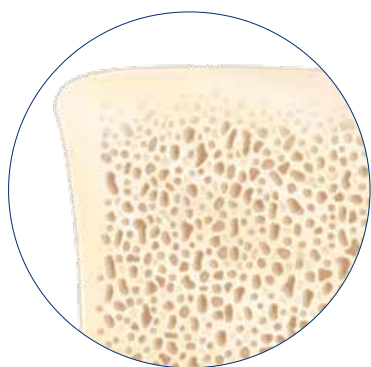
Healthy bone

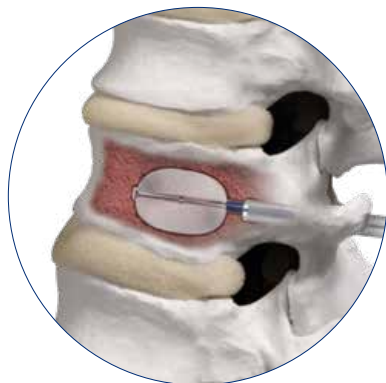
The balloon is then inflated, creating a void, or cavity, on the inside of the vertebral body. Once the void is created, the balloon is deflated and removed.

Balloon inflation
